Tree Replacement Proposals

Cardross Road, Dumbarton

Planning Application Reference – DC21/211/FUL

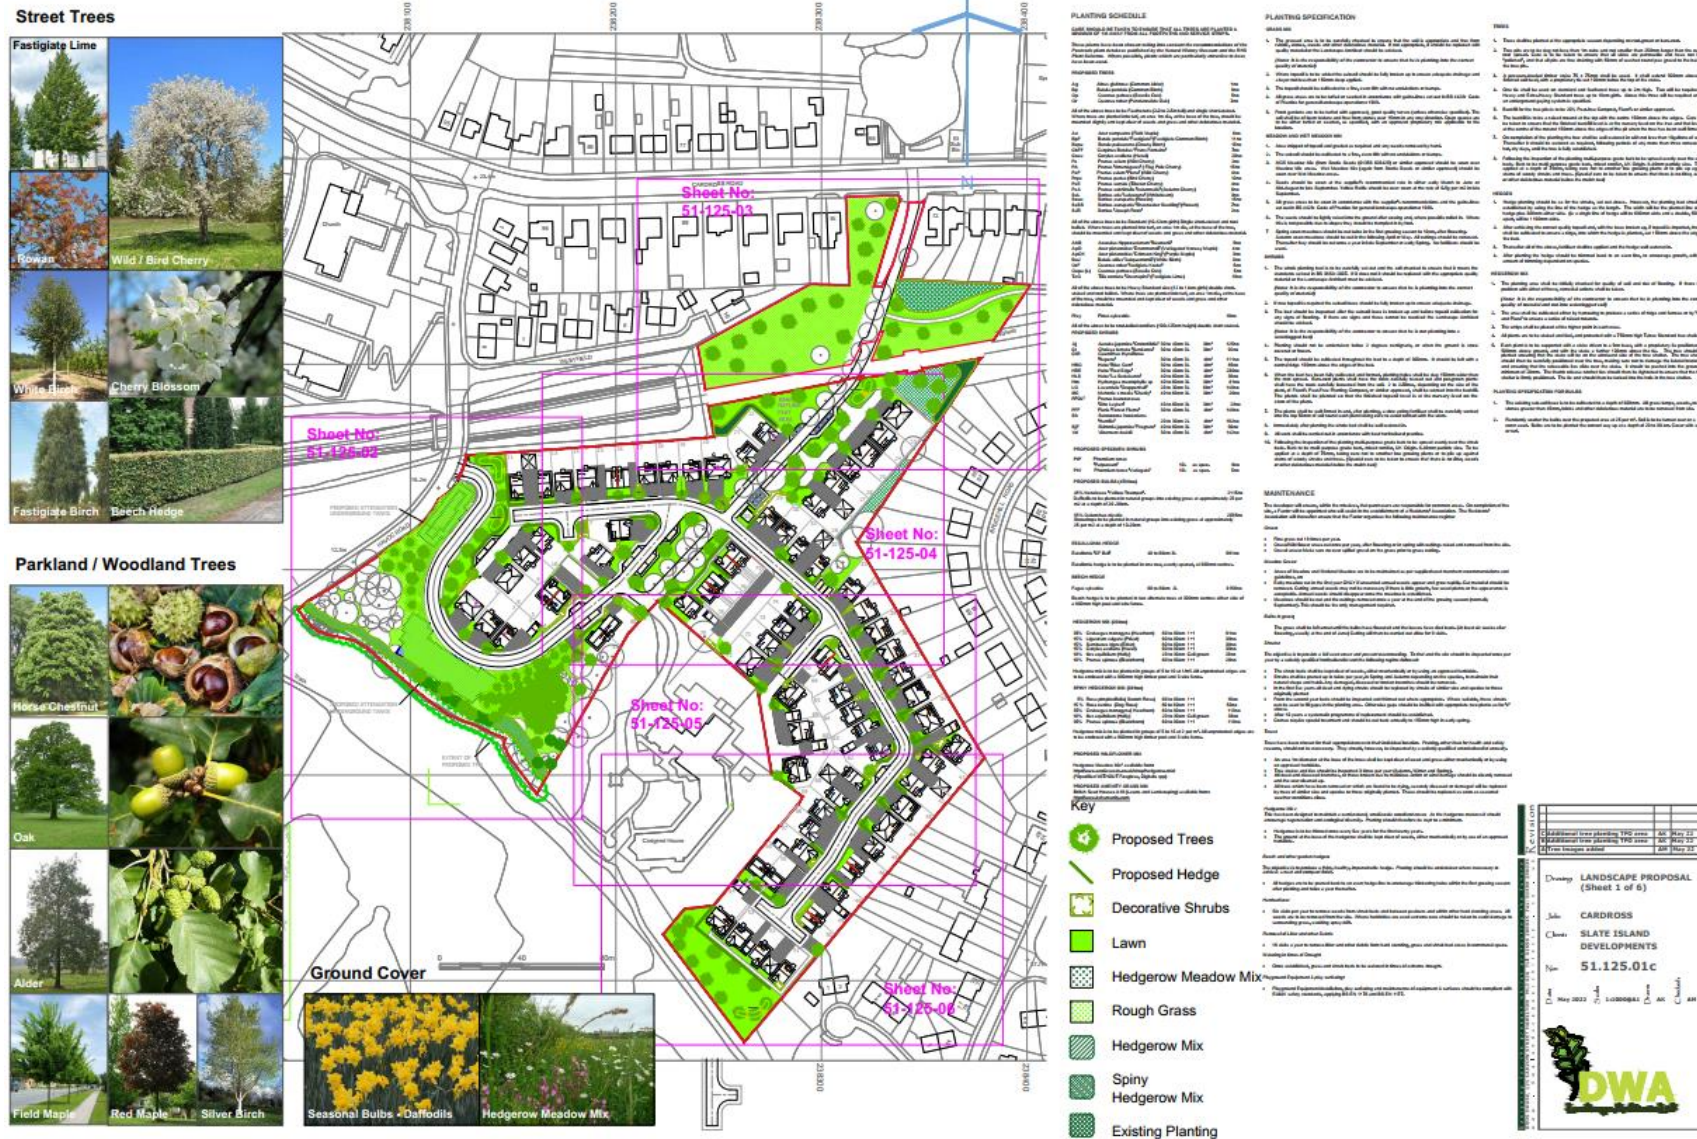
5.2 Landscaping drawing (also attached as an appendix for ease of reading)

- 5.1 The following landscaping proposal has been undertaken by DWA Landscaping and forms the basis of the overall development, however it should be noted that the TPO area is of course supplemented with the proposal as detailed within this report.
